# Post fire weed control and revegetation following bushfire in an urban environment at Bendigo, Victoria

Black Saturday Victoria 2009 – Natural values fire recovery program

**This project is No. 25 of the program 'Rebuilding Together' funded by the Victorian and Commonwealth governments' Statewide Bushfire Recovery Plan, launched October 2009.**

Published by the Victorian Government Department of Sustainability and Environment Melbourne, April 2012

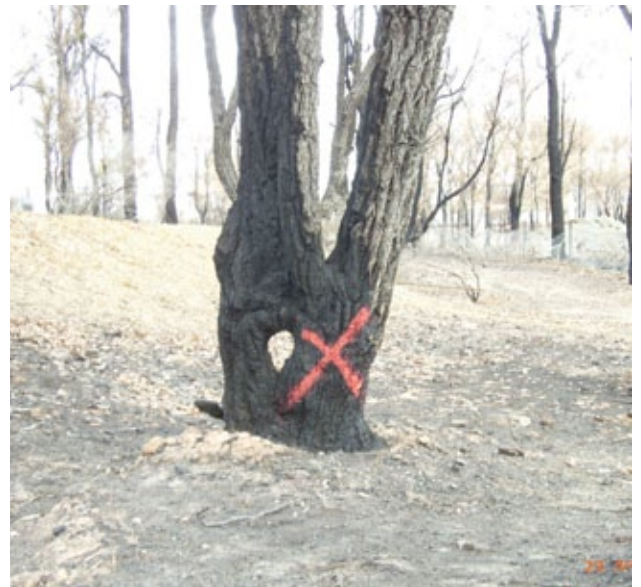
Figure 2. A dangerous tree on Keenes Road site (P128020) marked for removal after the 2009 bushfire (Calum Walker).

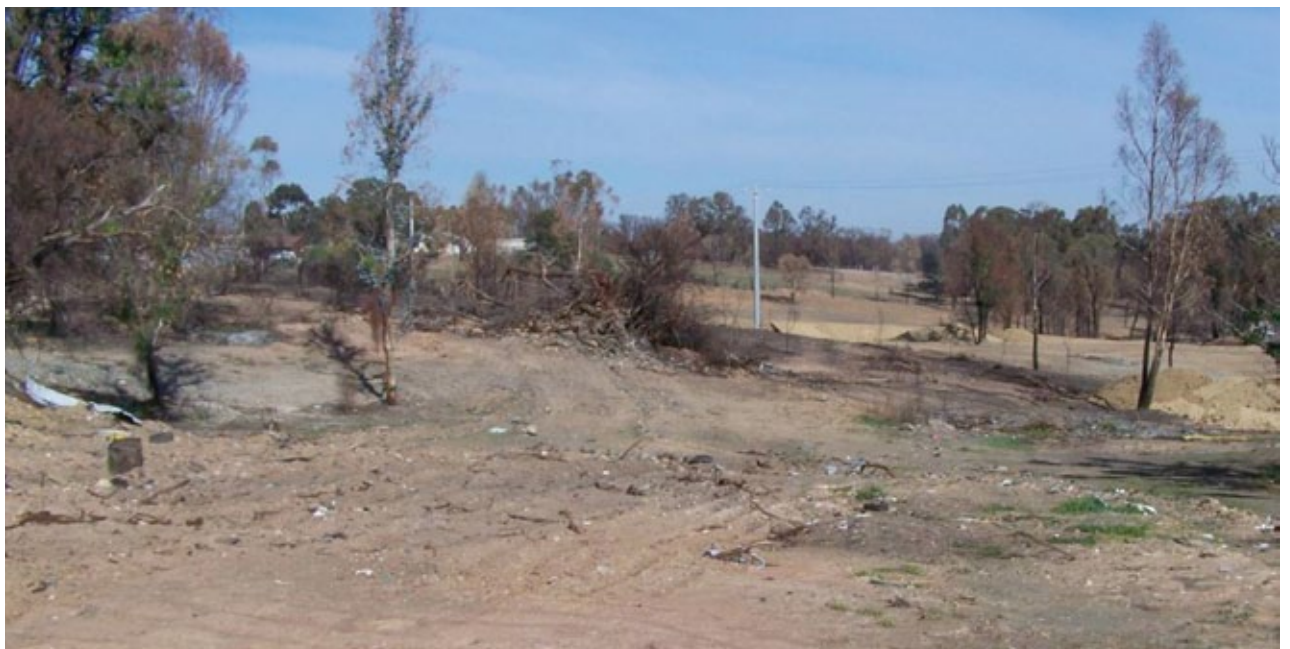
Figure 3. An example of bare ground on Crown land at Bendigo, after the 2009 bushfire, showing conditions favourable for the establishment of weed species (Calum Walker).

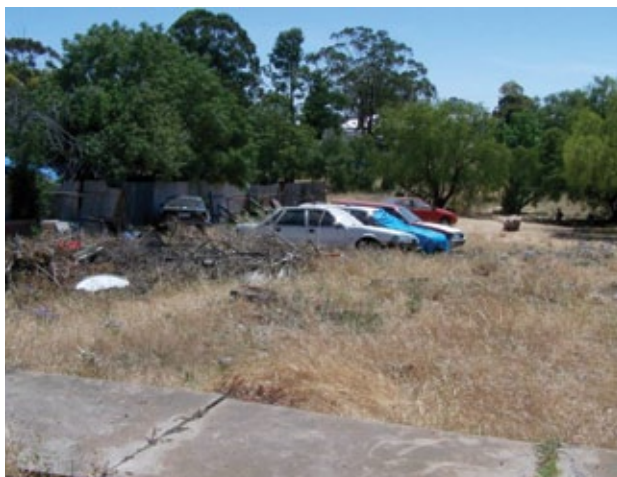
Figure 6. Typical unauthorised use (rubbish dumping, vehicle storage and stock grazing) of Upper Road site (P126048), pre fire 17 November 2008 (Calum Walker).

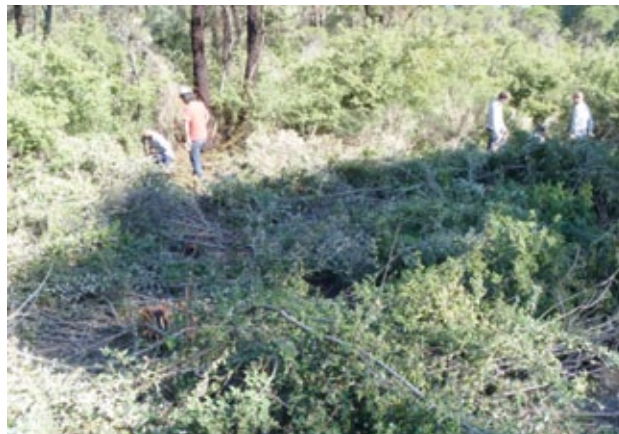
Figure 7. Green Corps crews manually removing woody weeds at Speedy Street site (P125989) (Charlie Dangerfield).

Two manual methods were used for weed removal. The cut and paint method involved cutting woody weed stems off near ground level and immediately painting the stump with herbicide — generally products with glyphosate as the active ingredient — according to label instructions. This technique prevents regrowth of the plant and kills the root system. Debris from cut tops were then stacked for removal or burning.

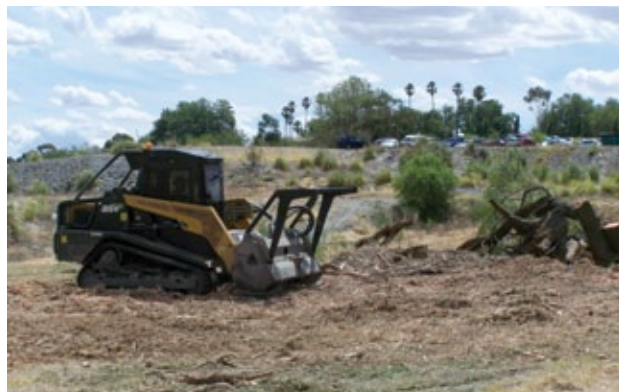
Figure 8. A skid-steer groomer working on Crown land at Bendigo, February 2010 (Calum Walker).

A groomer (flail mower) mounted on either an excavator or a skid-steer bobcat was used to remove smaller woody weeds such as Blackberry, Briar Rose, Cotoneaster and Broom.

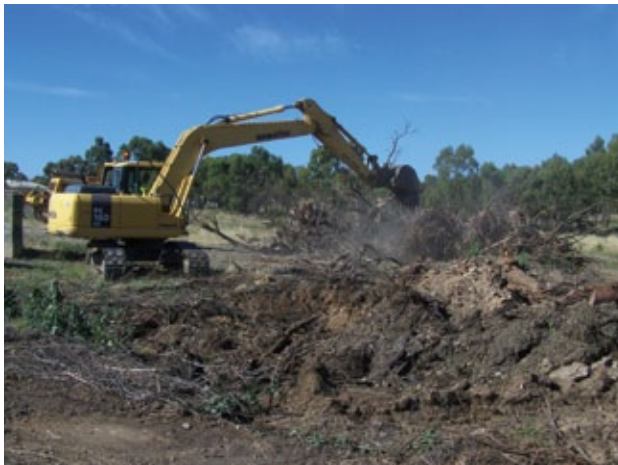
Figure 9. An excavator removing large woody weeds from Happy Valley Road site (P127499), December 2009 (Calum Walker).

Depending on the site, a bulldozer, excavator, front-end loader or bobcat was used to clear land that was entirely infested with weeds, particularly when large woody weeds dominated a site. When such heavy machinery was used, the resulting detritus was either mulched on site, removed for offsite burning, removed from the site to landfill (particularly in the case of *Opuntia* species and other cacti or succulents) or stacked and burnt onsite (in the case of

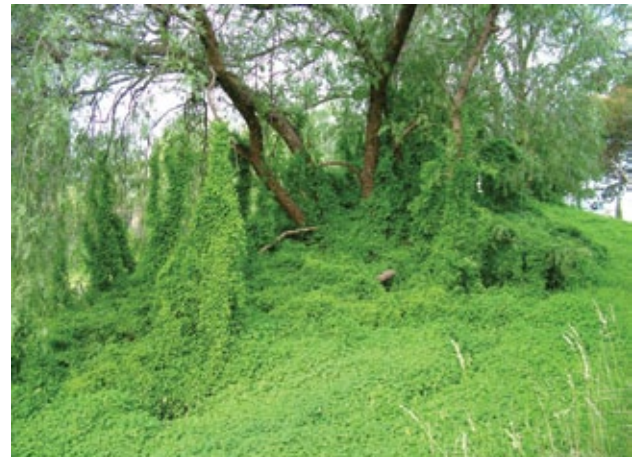
12a

Figure 12. a) California Gully School site (P126010) pre-fire weed infestation showing Bridal Creeper growing amongst Peppercorns; b) following treatment in August 2011.

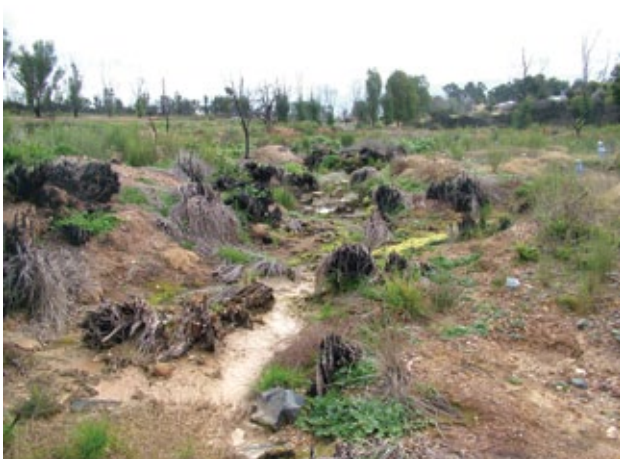
**13a**

Figure 13. a) Dai Gum San site (P126059) weed control works; 13b) Regeneration after weed control.

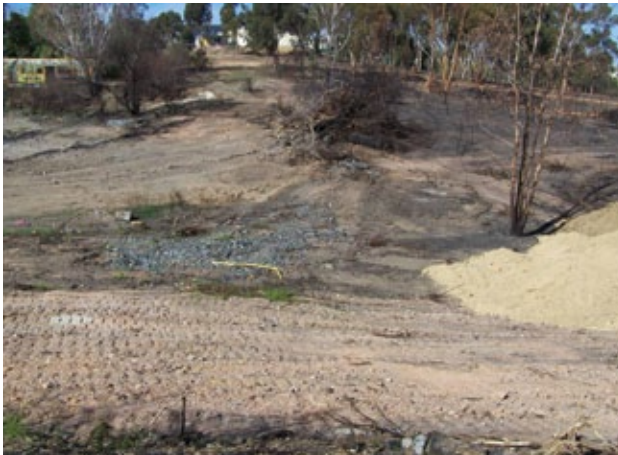
**16a**

Figure 16. Vinton Street, California Gully, a) Post-fire site work June 2010; b). Regeneration of native vegetation following weed control and site works, February 2011.
