# Barwon River Barrage Vertical Slot Fishway Construction - Summary Photo record

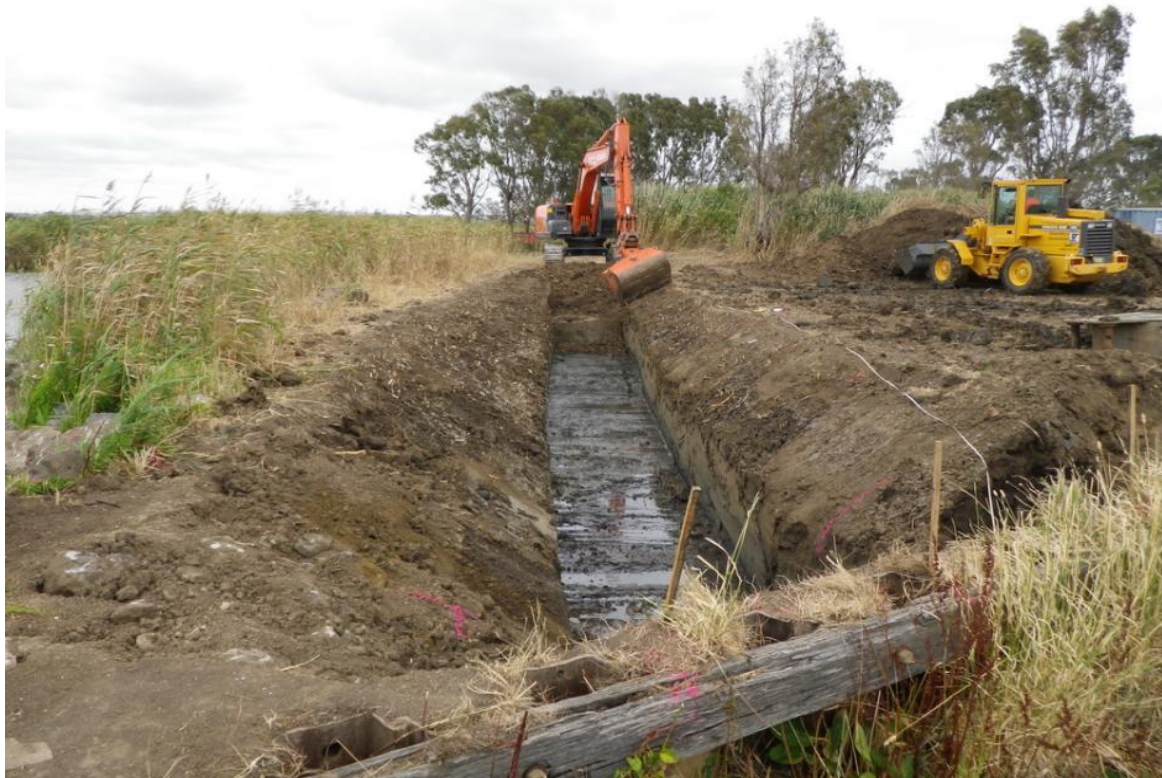
Channel extends back towards upstream bank exit.

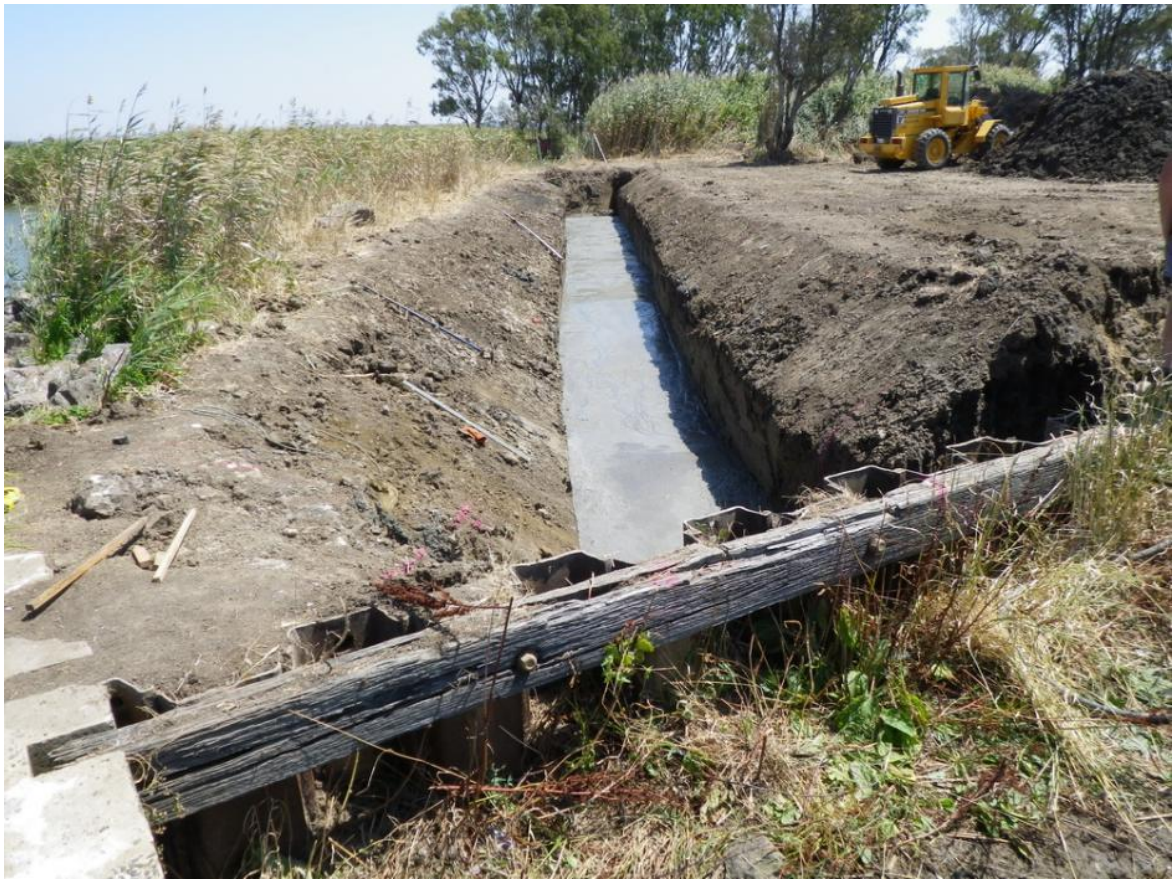
**Channel is completed and a blinding concrete base is poured to help slab construction.**

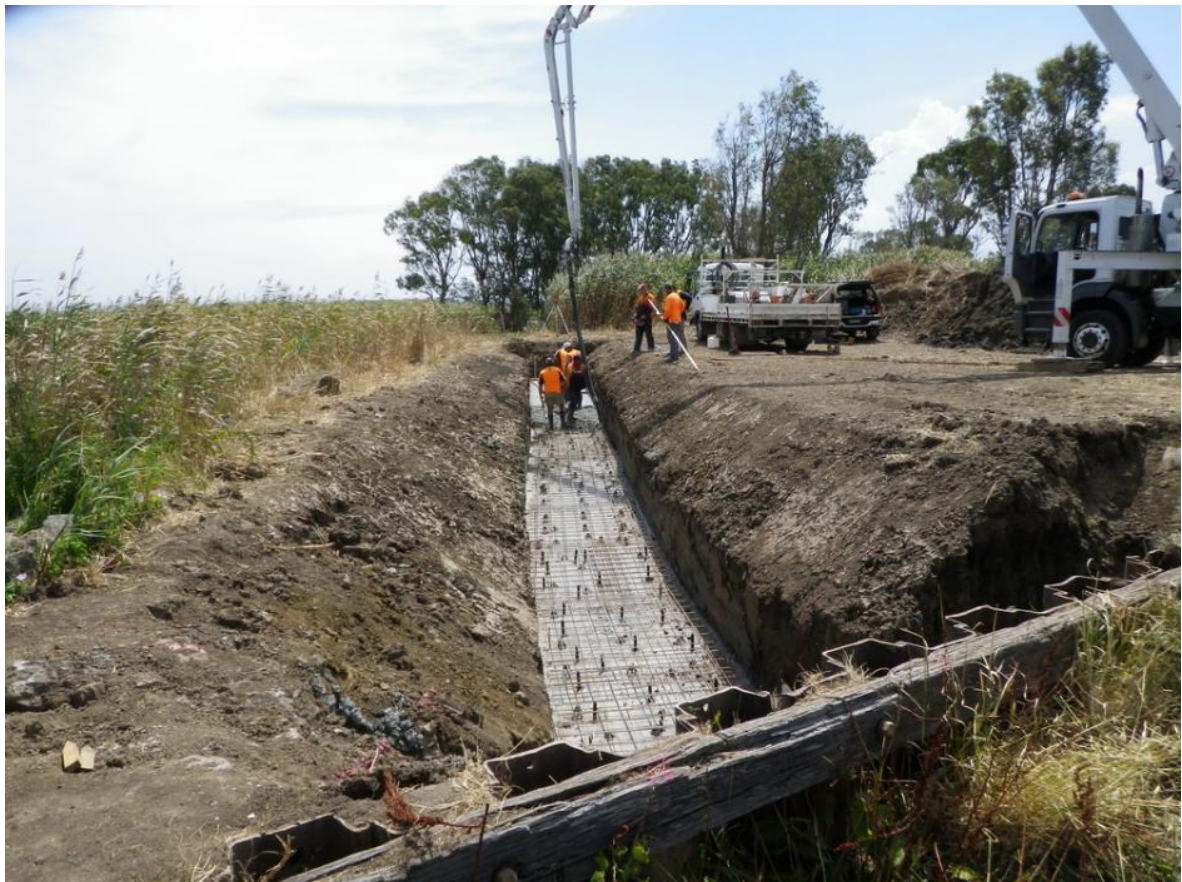
**The following day some water enters the site and is pumped and slab formed and poured.**

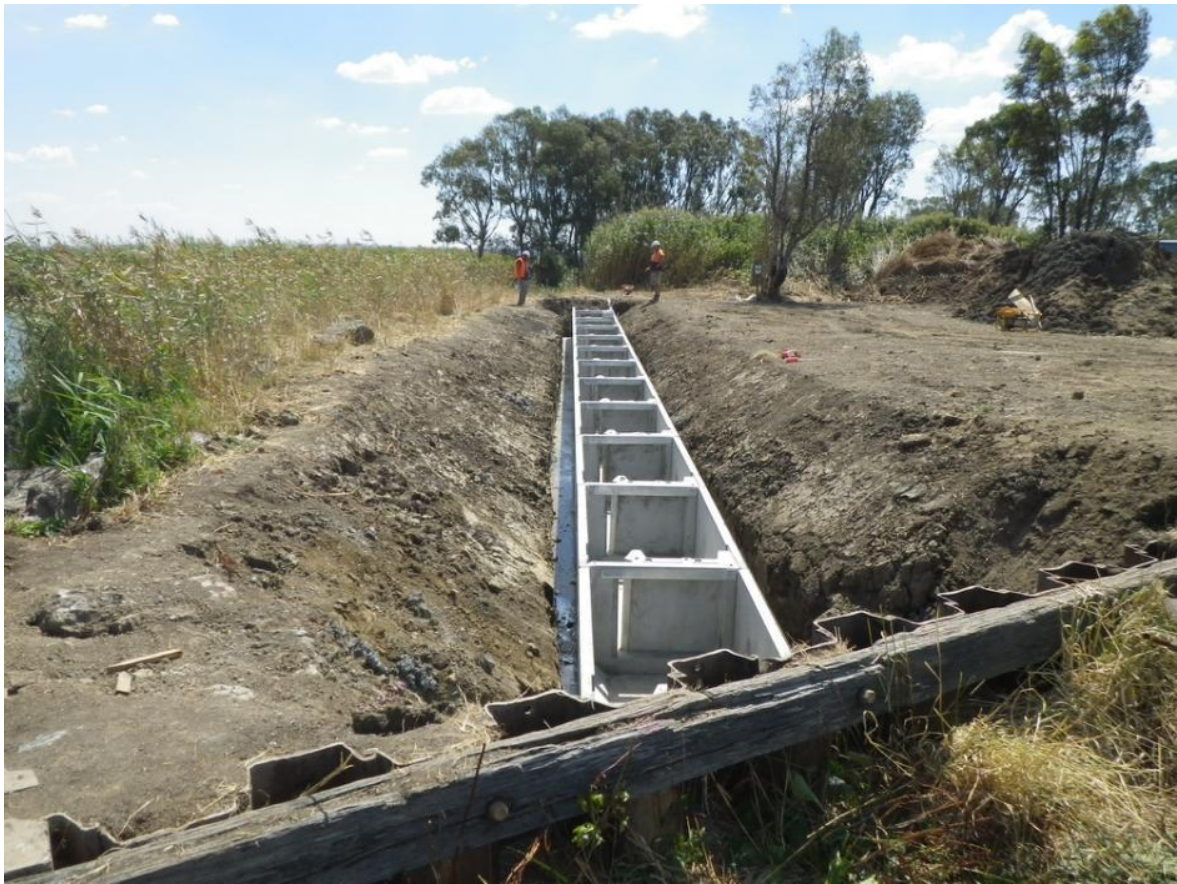
**Upside down culvert units are placed on the slab which form the fishway channel.**

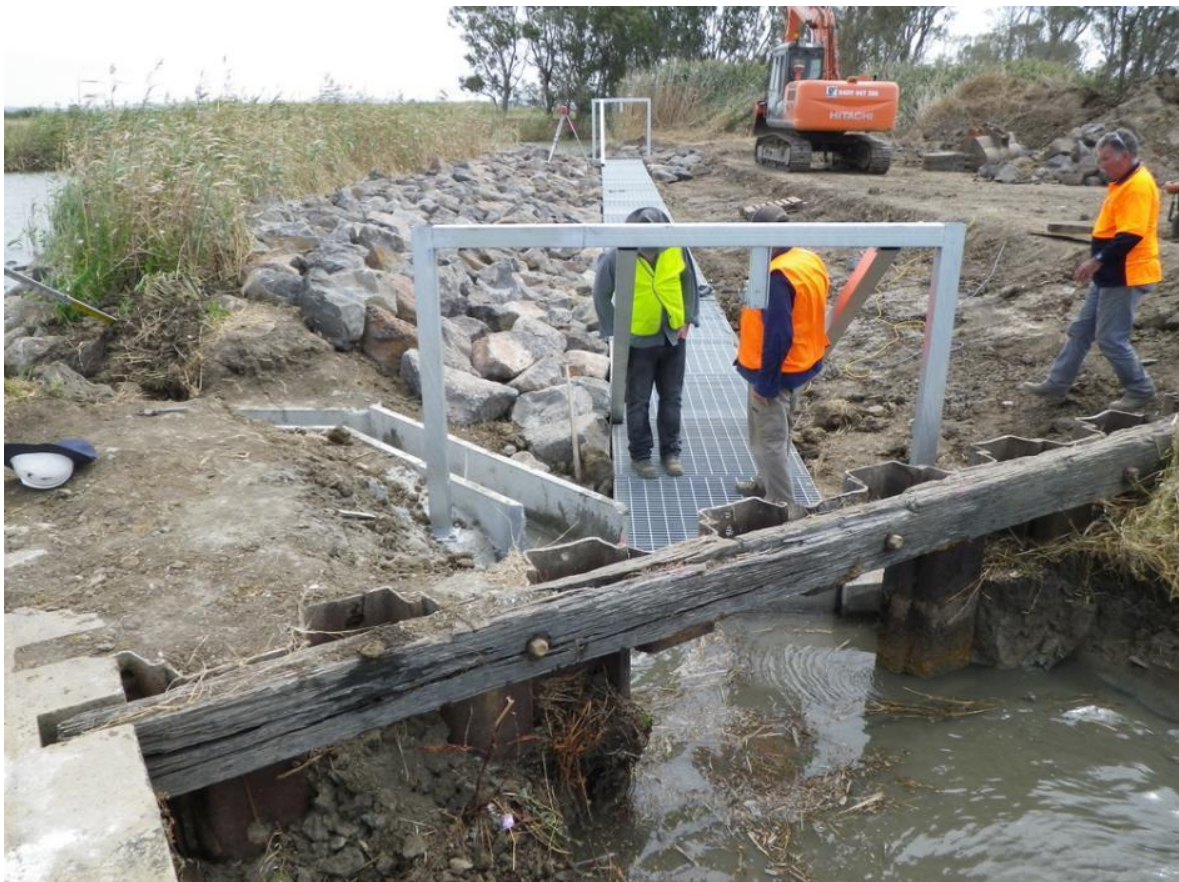
**A trench is dug for the attraction flow channel. Concrete is poured around the culvert units and attraction flow channel to secure the structure. Rock is placed along the banks of the fishway to reinforce the banks against erosion, gantry for gates installed and remaining concrete poured.**

**Sheet pile is removed and fishway is opened.**

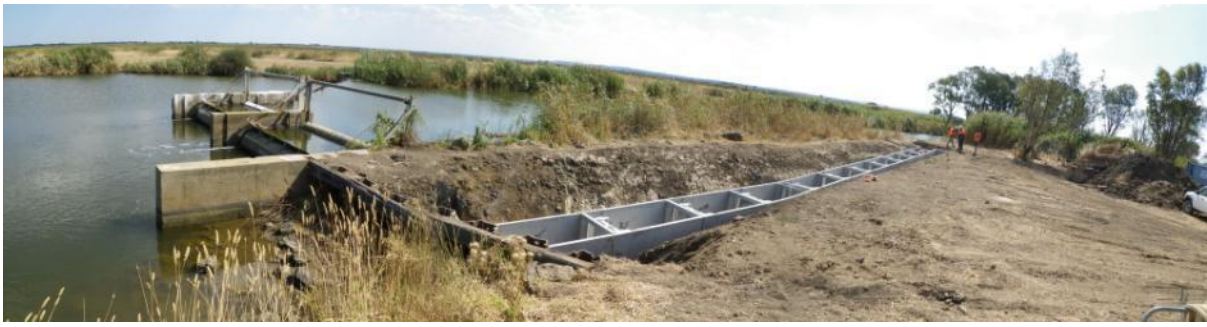
**Panoramic photo of site during construction.**

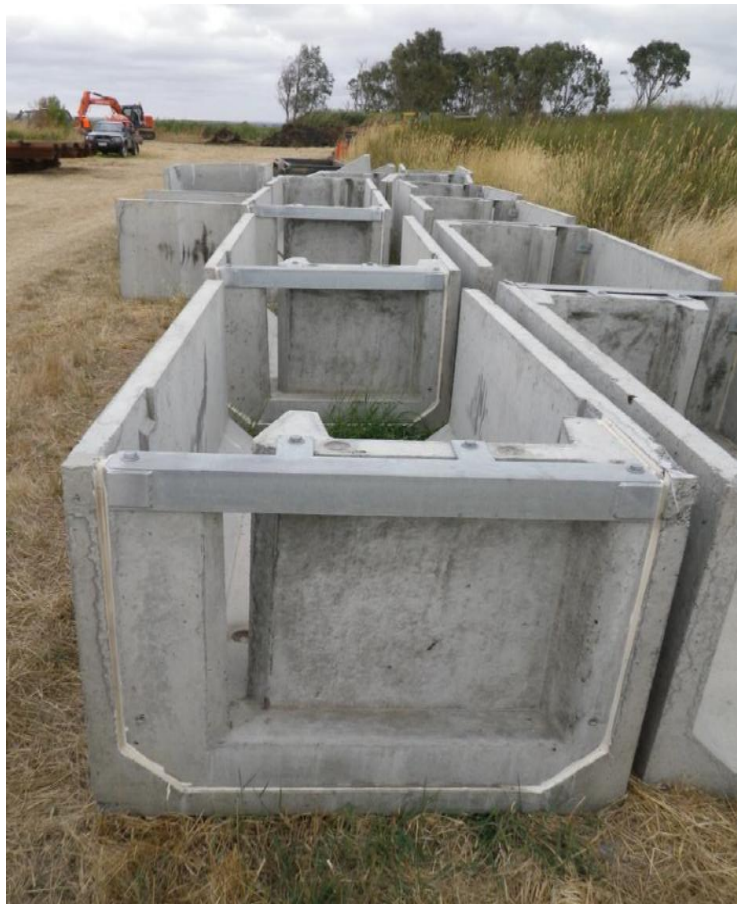
**Culvert units used in the fishway construction.**

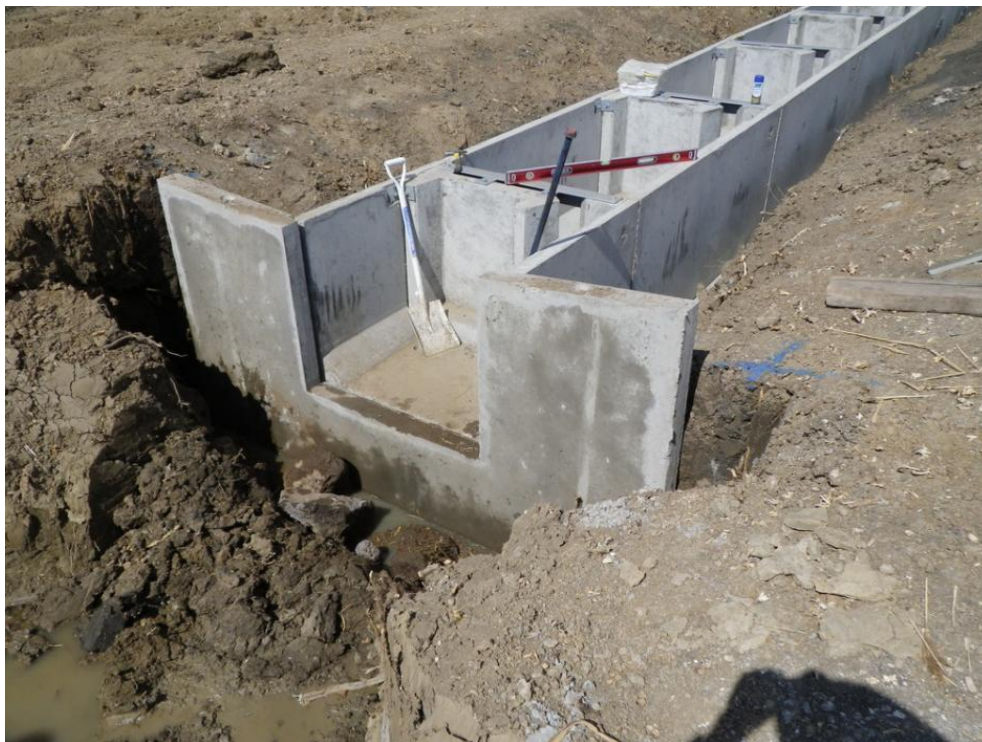
**Cutoff walls were placed at upstream and downstream end of fishway.**

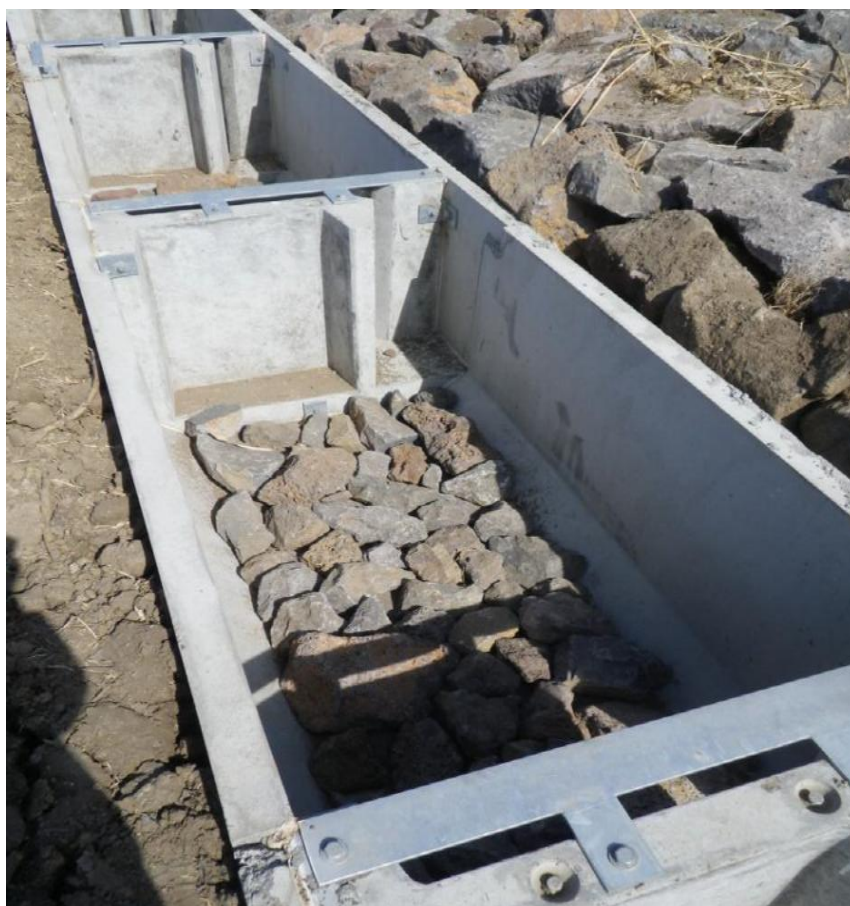
**Rocks were placed in the bottom of the fishway to enhance roughening.**

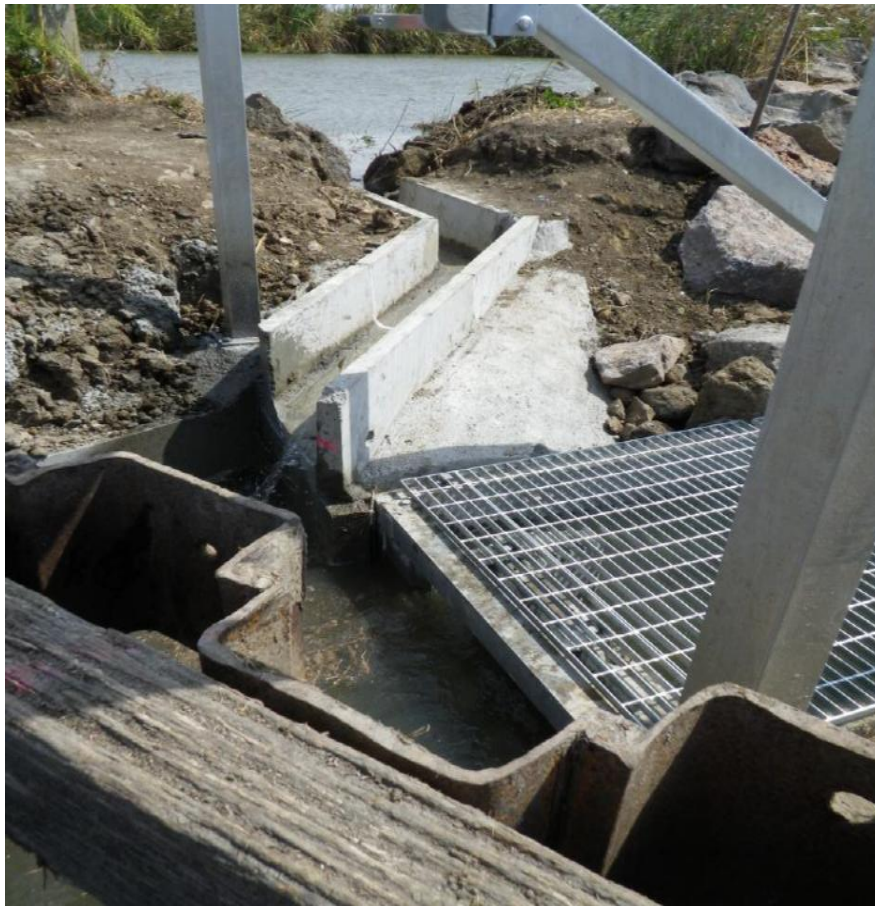
**An attraction flow channel provides extra water to fishway entrance.  
 Plunging flow chosen to maximise noise attraction.  
 Attraction flow operates to 100mm below FSL (maximum allowed)**

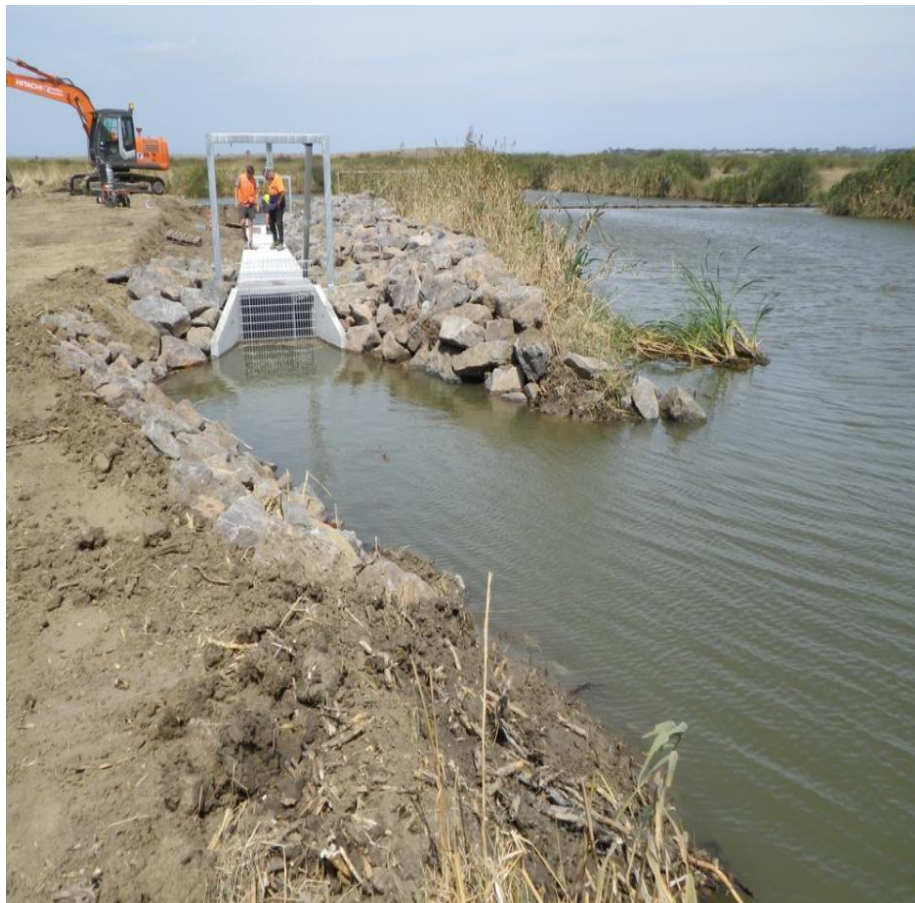
**Upstream exit recessed into bank and rock lined (temporary grate in place).**

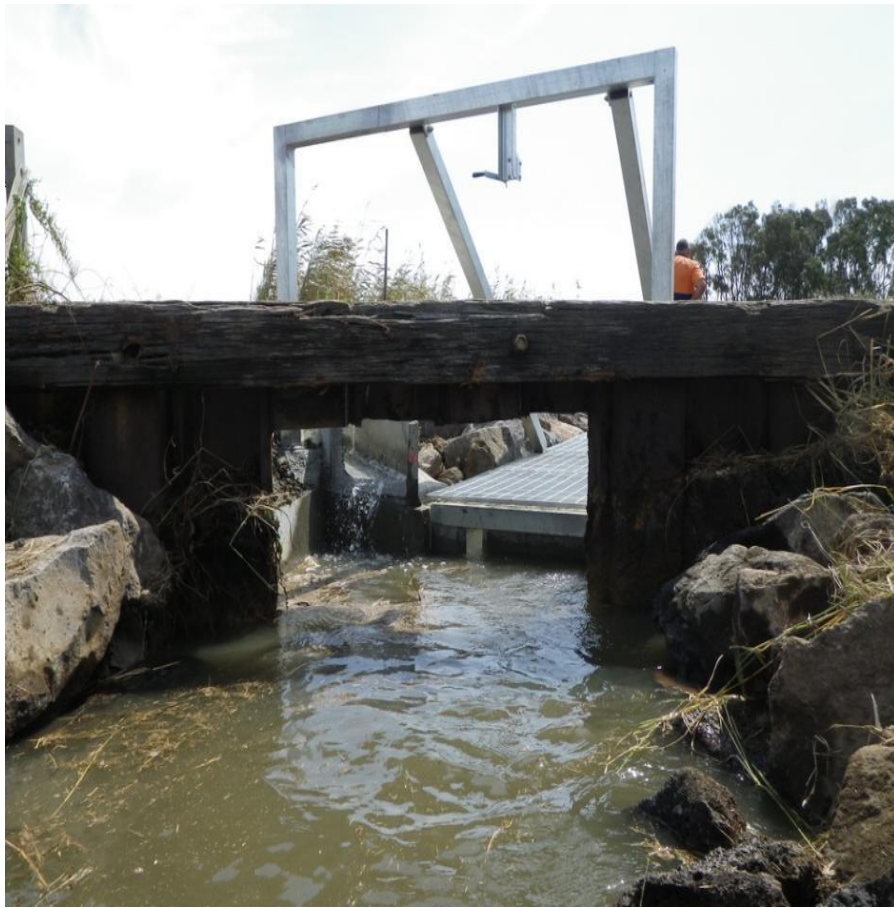
**Entrance set behind sheet pile wall to reduce construction time and maximise site safety and retain weir integrity (hence a hole rather than a slot).**

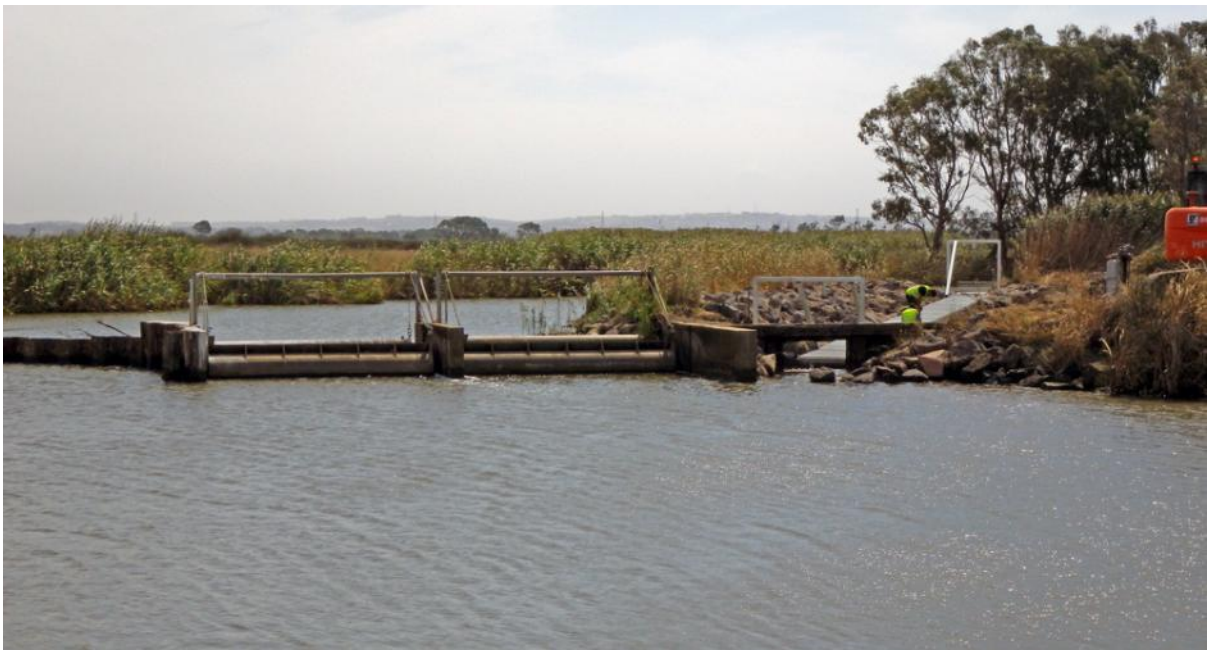
**Entrance placed to right of main gates of weir. A small rock groin places fishway flow adjacent to the abutment wall.**

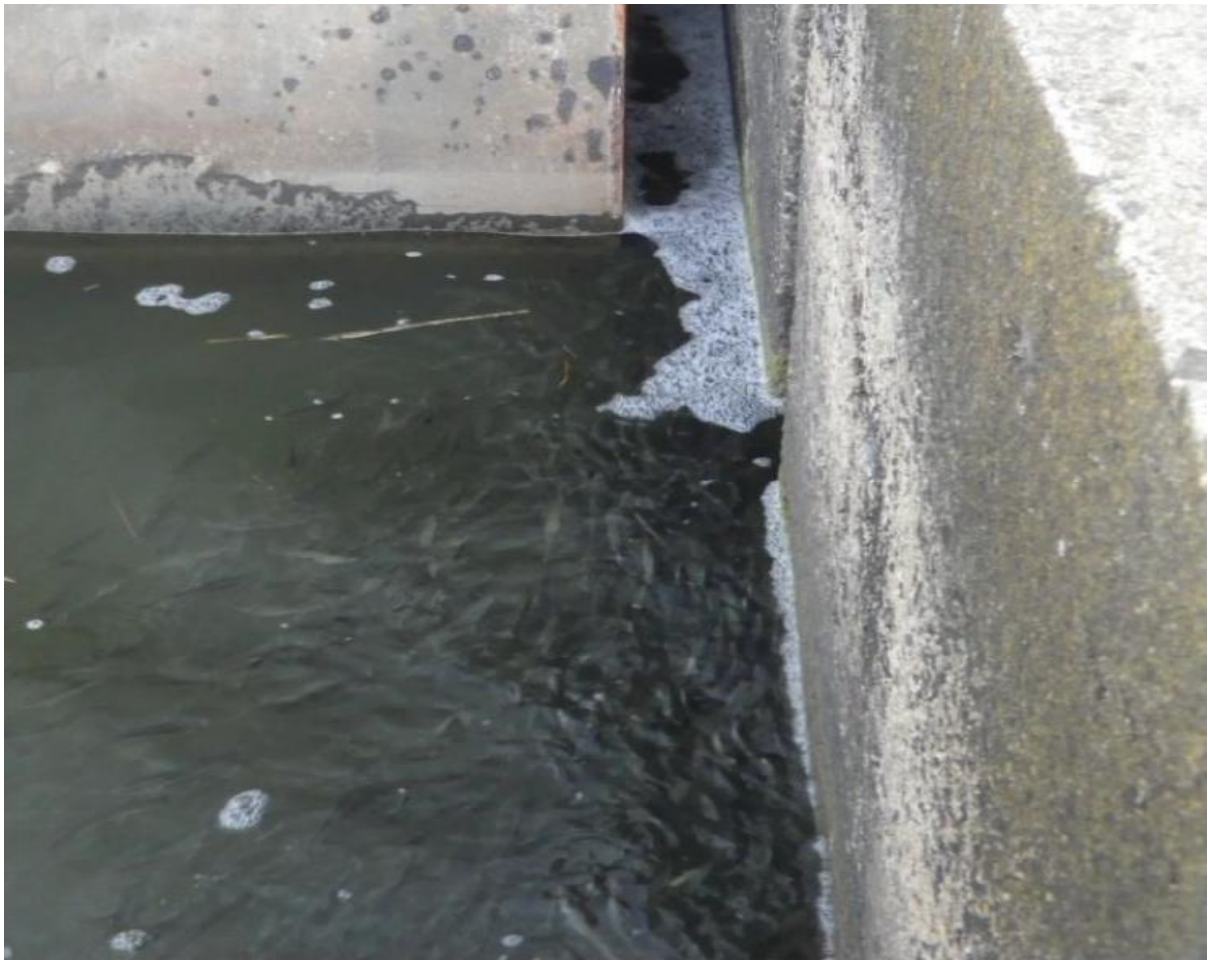
**Fish piling up below the gates prior to fishway construction, these fish (mullet and galaxias) were happily finding and ascending the fishway immediately after the fishway was opened, even while the excavator still worked!!!**

**Day two (22/02/2013) of operation had fish successfully ascending fishway, with thousands visible below, within and exiting the fishway. Construction time was 8days from breaking ground to passing fish.**
